Manhole Inspection Summary

Manhole # S17E1_004MH

Location Address: **2905 whittington av**

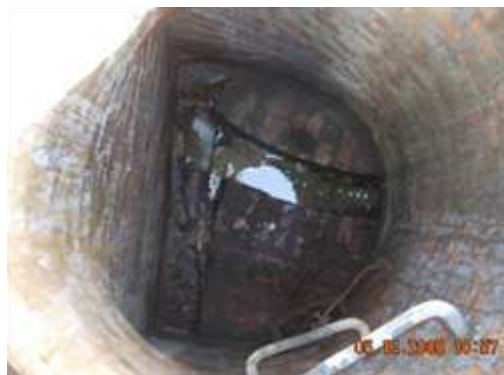
Top View

channel pipe connections

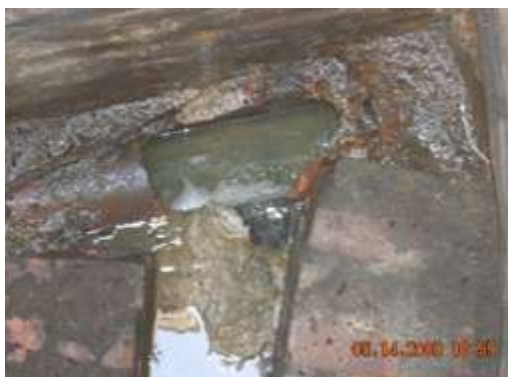
Defect 1

Comments **manhole built around existing pipe**

break in of an existing pipe in channel

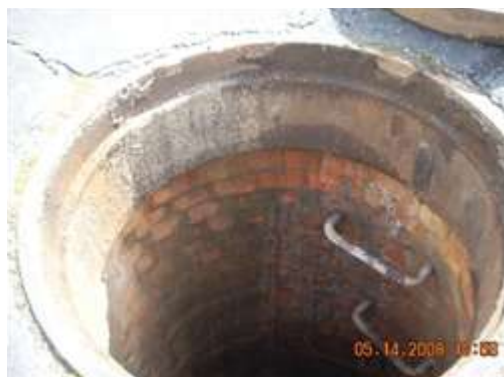
Defect 4

Frame Offset: **0** (in.) Condition: ☐ Sound ☐ Cracked ☒ **Leaks**

frame leaks-inflow evidence

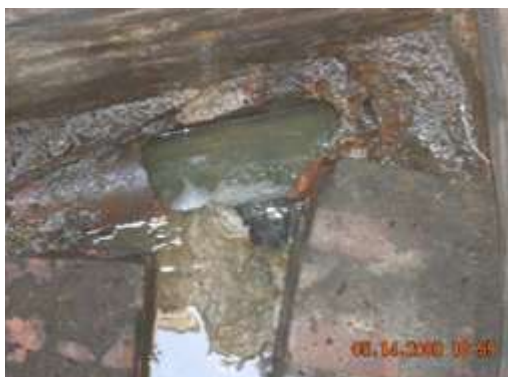
Defect 3

Condition: ☐ Sound ☐ Cracked ☐ Root Intrusion ☐ Deteriorated ☐ Leaks ☒ **Debris**

debris in channel and bench

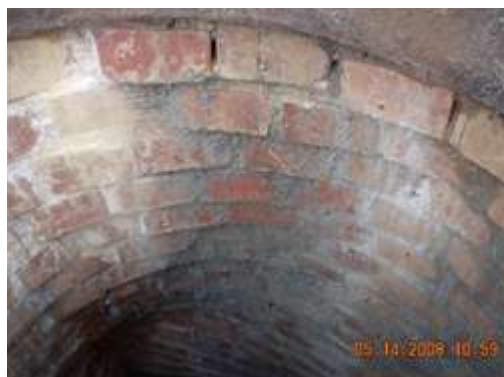
Defect 2

Infiltration: ☐ None ☒ **Joint** ☐ Cracks ☐ Mortar ☐ Roots ☐ Wall

infiltration @ corbel/frame joint

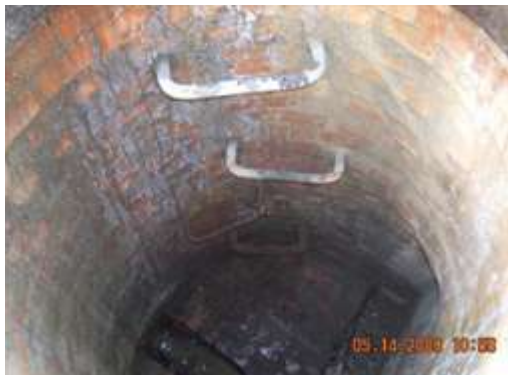
Steps Count: **4** Missing: **0** ☒ **Corroded**

corroded steps

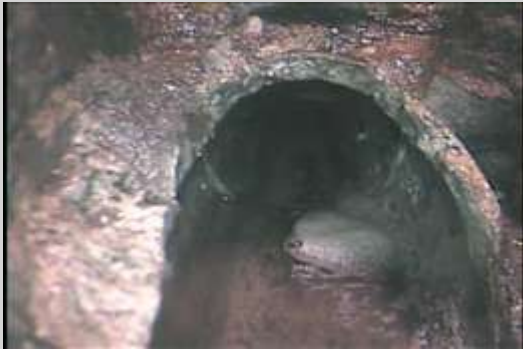
12 O'Clock Outflow

6 in. Circular Gravity Sewer
Pipe Out @ 12 O'Clock

Pipe Height: **6** (in.) Rod and Bar (Angled)
Pipe Material: **Clay** ☐ Pipe Lined
Invert Depth: **7.29** (ft.) Flow Characteristics: **Slow**
Deposits: ☒ None ☐ Mud ☐ Sludge ☐ Debris ☐ Grease
Silt Depth: **0** (in.) Deposits Extent:
Infiltration: **Weeper** Pipe Seal Cond: **Broken**

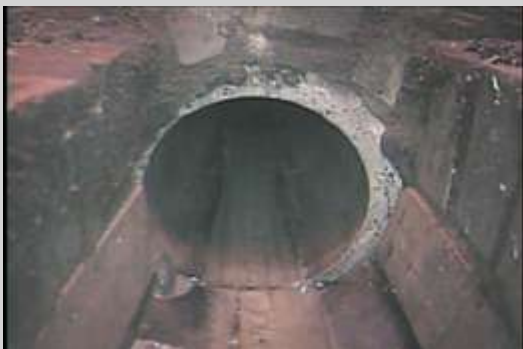
3 O'Clock Inflow

6 in. Circular Gravity Sewer
Pipe In @ 3 O'Clock

Pipe Height: **6** (in.) Rod and Bar (Angled)
Pipe Material: **Clay** ☐ Pipe Lined
Invert Depth: **6.92** (ft.) Flow Characteristics: **Slow**
Deposits: ☒ None ☐ Mud ☐ Sludge ☐ Debris ☐ Grease
Silt Depth: **0** (in.) Deposits Extent:
Infiltration: **None** Pipe Seal Cond: **Sound**

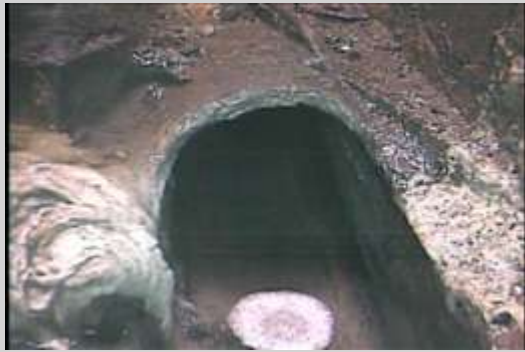
6 O'Clock Inflow

Infiltration: **Weeper**

Pipe Seal Cond: **Broken**
